## How Not to Build Roofs

By Joseph W. Lstiburek, Ph.D., P.Eng., Fellow ASHRAE

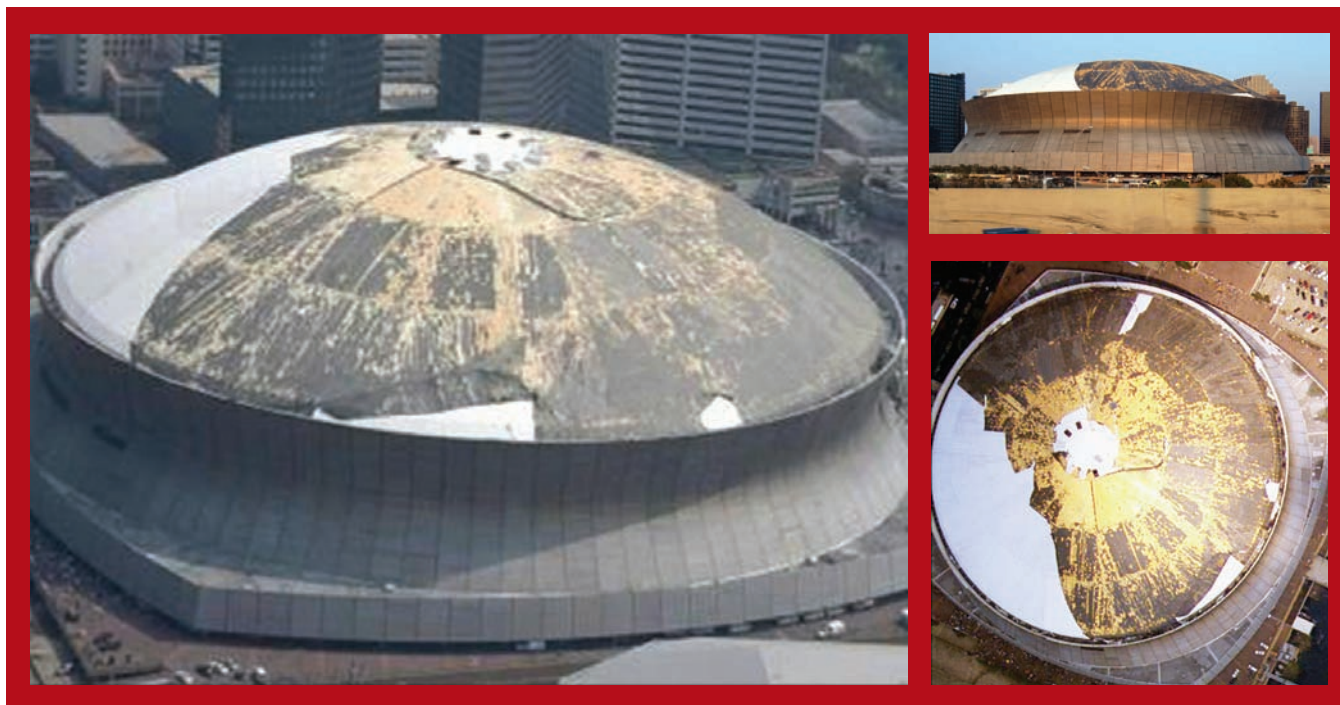
Photo 1: This never should have happened. The Superdome's roof membrane is missing after Hurricane Katrina in 2005.

I remind everyone that the roof of the Superdome experienced one of the more spectacular failures in enclosure history. It was ripped off during Katrina in less than catastrophic wind conditions (Photo 1). Let's toy with this memorable failure a little. Hypothetically, because there is litigation ongoing.\*

was reported that the smoke dampers at the top of the roof were sucked off during Katrina and that allowed the wind to enter, exacerbating building pressurization and stressing the roof assembly. The membrane took the majority of the load, unzipped and traveled to a neighboring parish.

Could it be that the lack of an air barrier caused the Superdome roof to fail in wind conditions that were pretty minor as far as hurricanes go? I'm asking hypothetically. And, how was the Superdome replacement roof that was installed in 2002 allowed to be constructed without an air barrier when the original roof that was installed in the 1980s had one? Where were the adults?

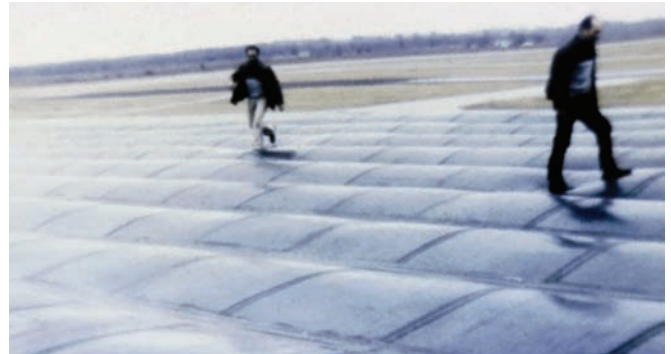
**Photo 2: Fluttering membrane. No air barrier at deck leads to an idea for a Disney World ride.**

When mechanically attached membranes became common—a bad idea in my humble opinion, the lack of an air barrier lead to fluttering of membranes (Figure 2), some interesting failures (Photo 2) and some interesting solutions (Photo 3).

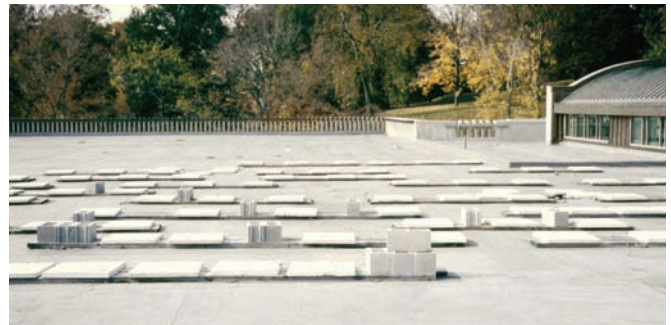
**Photo 3: Fluttering membrane fix. "I'll fix that darn moving membrane. Get me some pavers and blocks."**

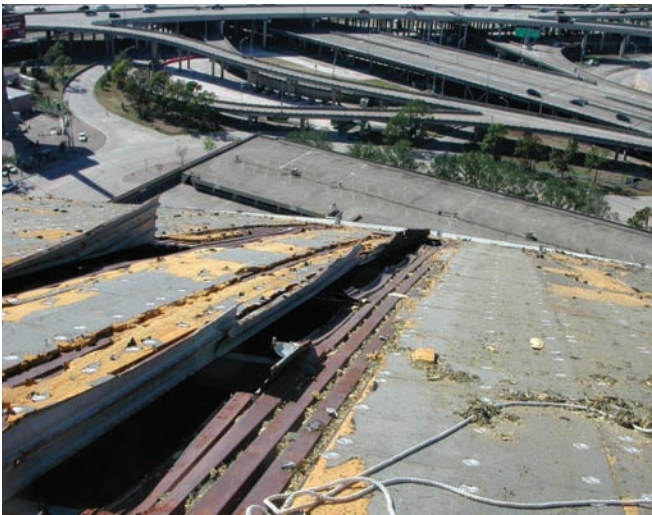
**Photo 4: Superdome roof damage. Missing membrane and exposed rigid sheet insulation. Note the mechanical connectors. The membrane was adhered to the top of the sheet insulation boards and to the mechanical connectors. Also, note the metal deck and the flutes that allowed lateral airflow and lateral water migration.**

Here is a trick question: what is the tightest element of a roof? That would be the element without any holes, which is the membrane since it can't have holes. Otherwise, it leaks. So, if I have a tight membrane, rigid insulation installed in boards/sheets with gaps over a fluted steel deck with seams and holes, the majority of the wind load is taken by the membrane. That was the case in the Superdome roof (Figure 3). How do we know that? Well, the membrane is gone, and the insulation was left behind (Photo 4).

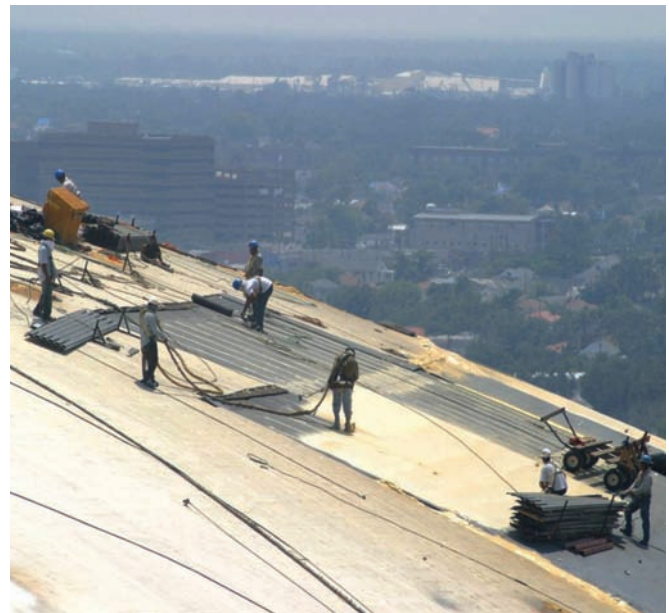
**Photo 5: Spray foam application. New fully adhered roof insulation and integral air barrier.**

The good news is that the post-Katrina repair is bulletproof<sup>†</sup> and has an air barrier. The new roof is similar to the original roof. It is a spray polyurethane insulation system applied directly to the roof deck (*Figure 4* and *Photo 5*). A spray applied fully adhered membrane is installed over the top of the insulation (*Photo 6*). The spray polyurethane insulation also acts as the air barrier.

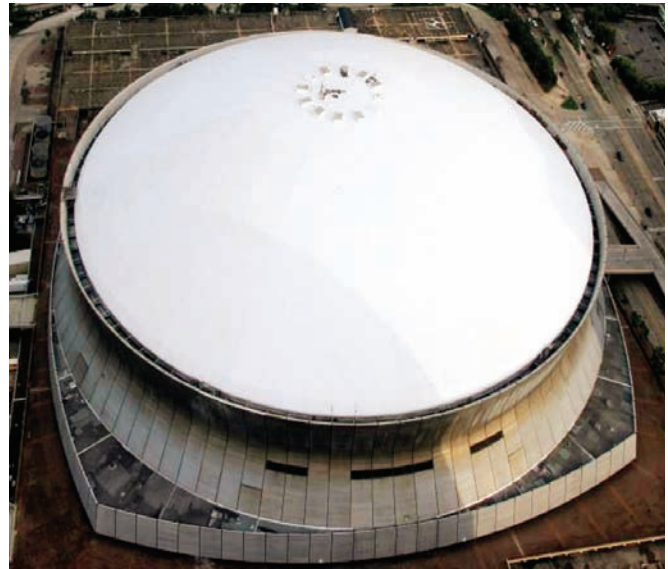
**Photo 6: Better than before. Welcome back Saints.**
